AVON LAKE

2025 Lake Management Study

Avon Lake Village HOA

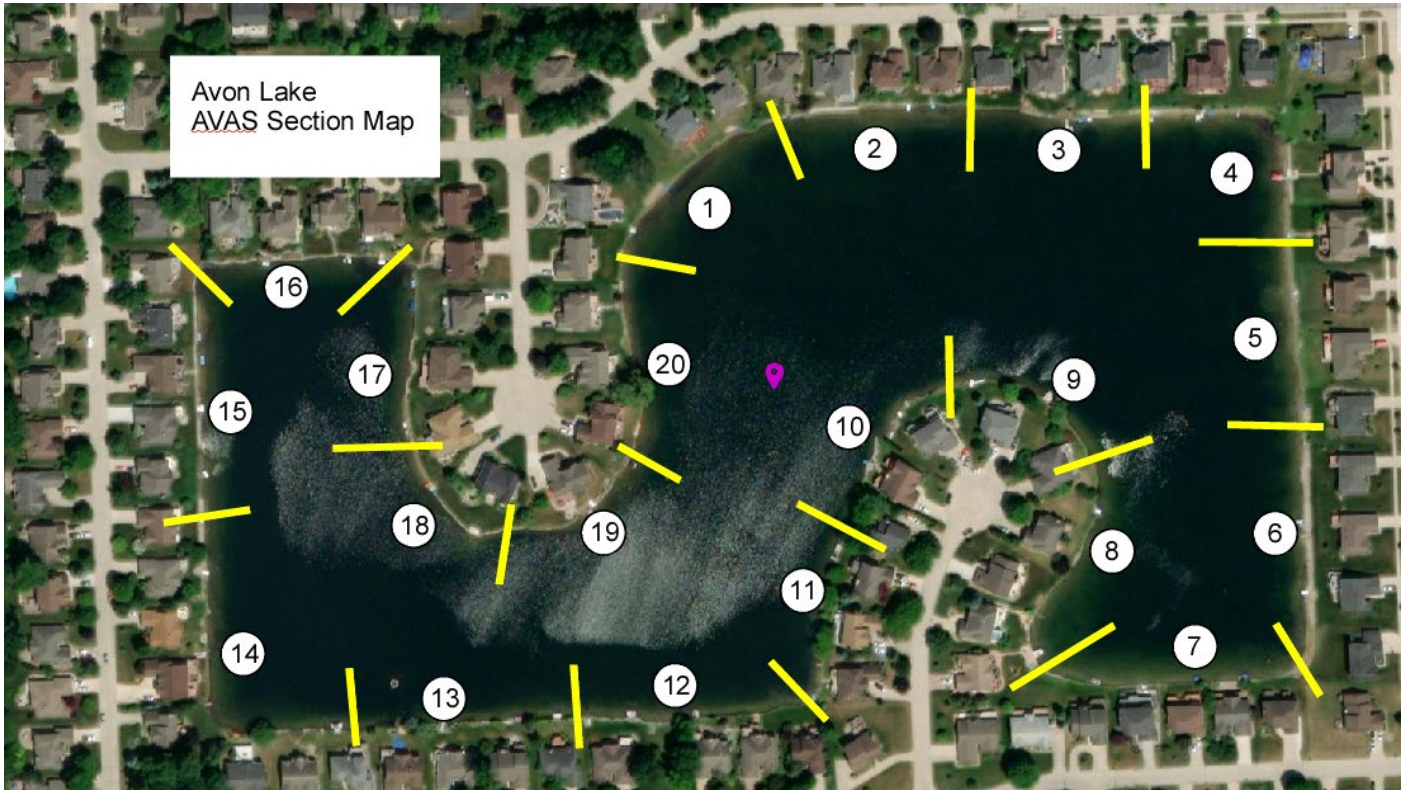
(For use with the next couple of pages)

There are 3 different sets of pages. The first is the summary page which gives you the lake wide plant coverage shown as an approximate percentage in column 11. Next is the lake map showing the numerous AVAS sections. The last set of pages are the density pages. Using the map and the density pages together you can determine what plant species exist in each section of the lake.

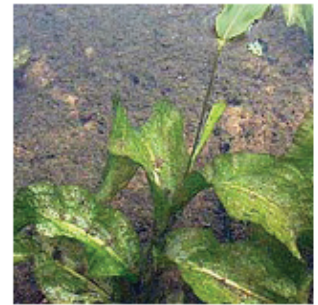
Large Leaf Pondweed

This plant has thick, large stems and broad leaves. The submerged leaves appear wavy and taper toward the stem. Floating leaves are egg shaped.

Concerns: If it grows out of control it can interfere with recreational activities.
